# Human-Robotics Alliance Saves the Day

Robot arms facilitate emergency space station repair

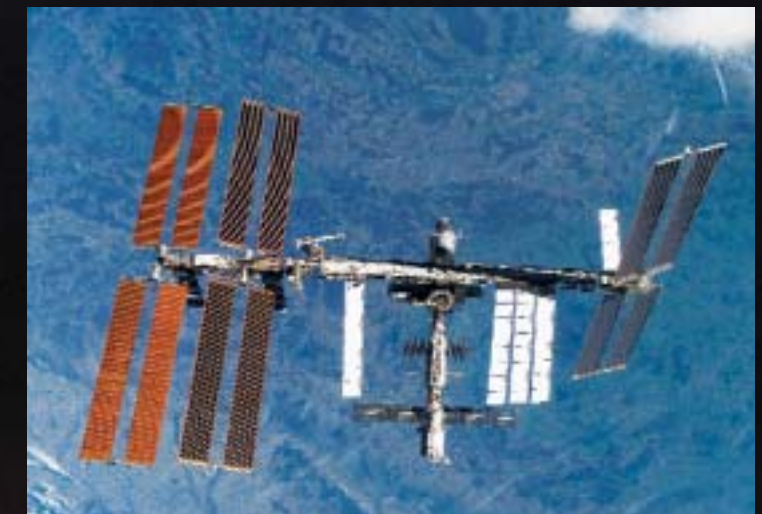
Backdropped by a colorful Earth, the International Space Station is seen from Discovery as the two separate. A station robot arm is visible as a white spar at the left end of the “track” that allows it to move from one end of the truss to the other. The damaged solar wing was at the extreme range of the arm's reach. The repaired site is the far lower array—about 40 percent of the way out toward the end where several “stitches” are visible as white lines that parallel the extended wing.

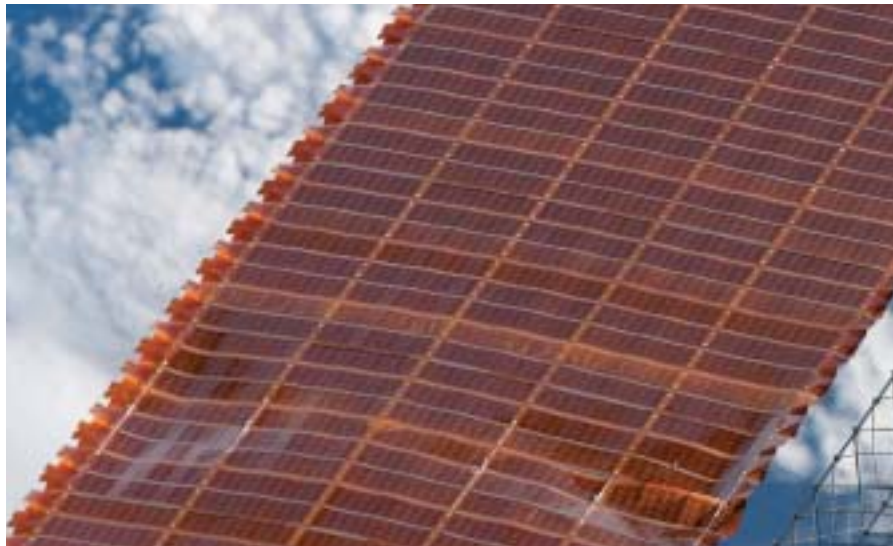
The repaired solar array was photographed by an STS-120 crew member aboard the space shuttle Discovery as it moved away from the International Space Station. The repair is in the foreground.

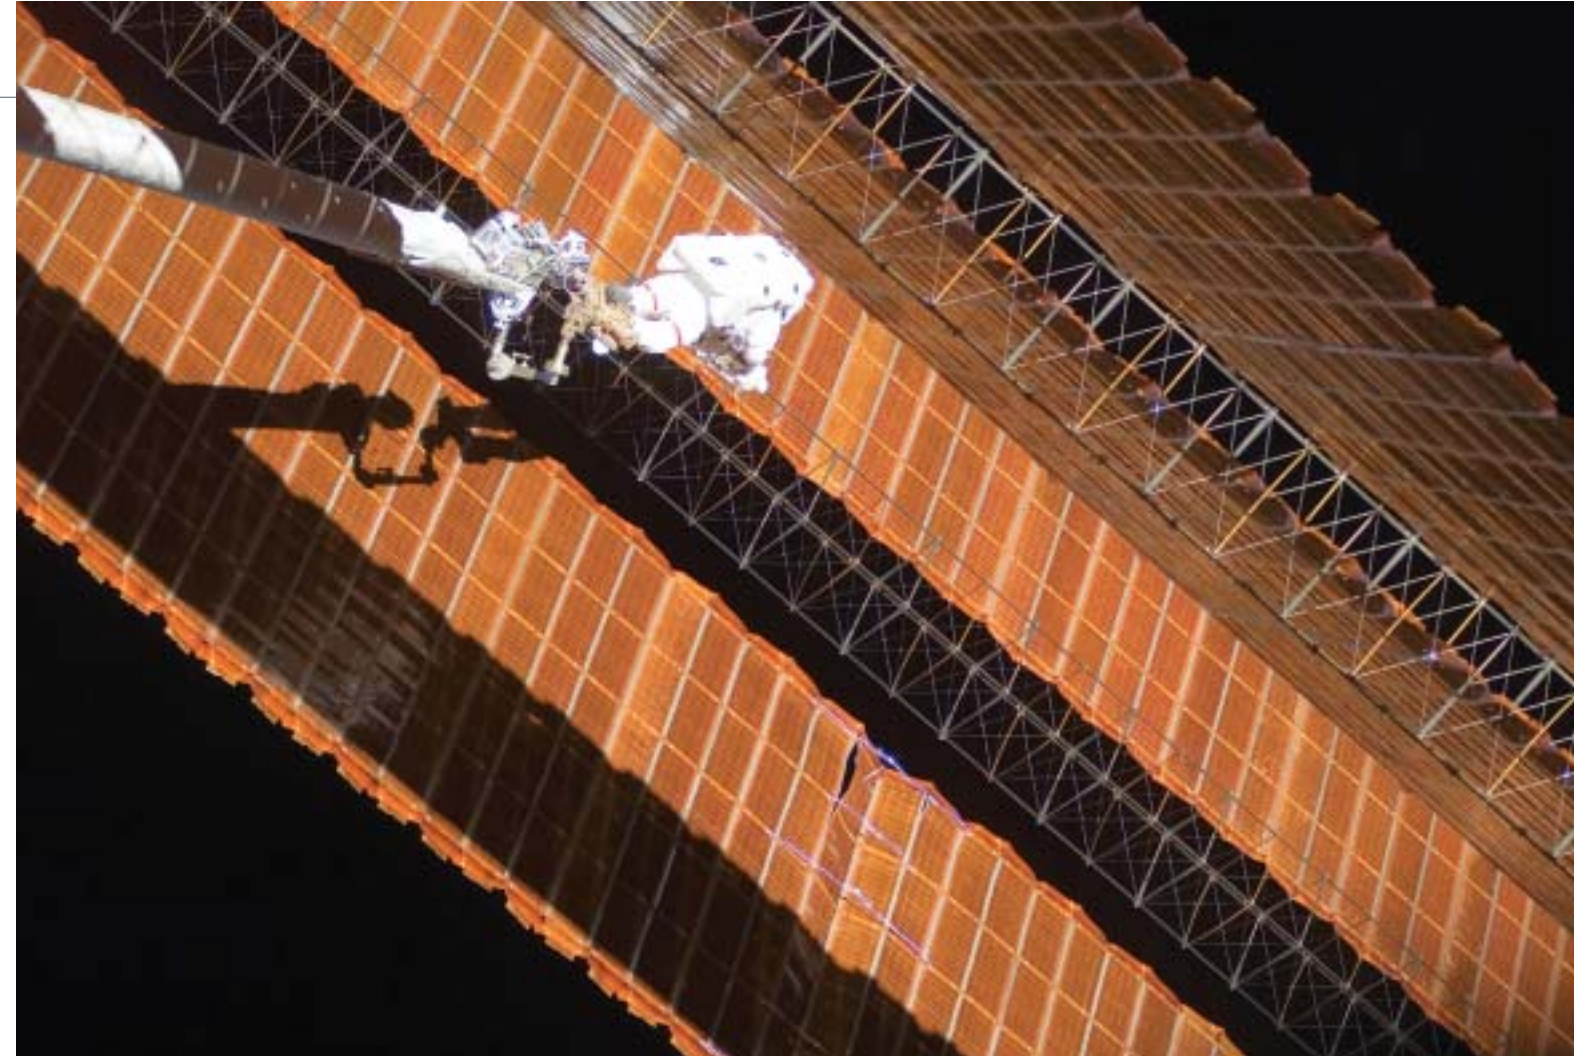
Waving the astronaut out at the end of the arm-held boom involved commanding multiple joints—both bending and rotation joints—in the Canadarm-2. And since the arm/boom combination would be at nearly its maximum extension, the end position was very sensitive to joint motions.

“We like to design joint motion sequences in advance and test them in our lab,” a NASA robotics expert had told newsmen before the spacewalk. “But in the rush to build this procedure, there’s been no time to optimize the motion”—that is, to design the joint command sequence to minimize the swings and turns of the astronaut at the end of the boom during the 45-minute ride to the site. He called the quick-draw plan workable but “painful”—that is, not elegant.

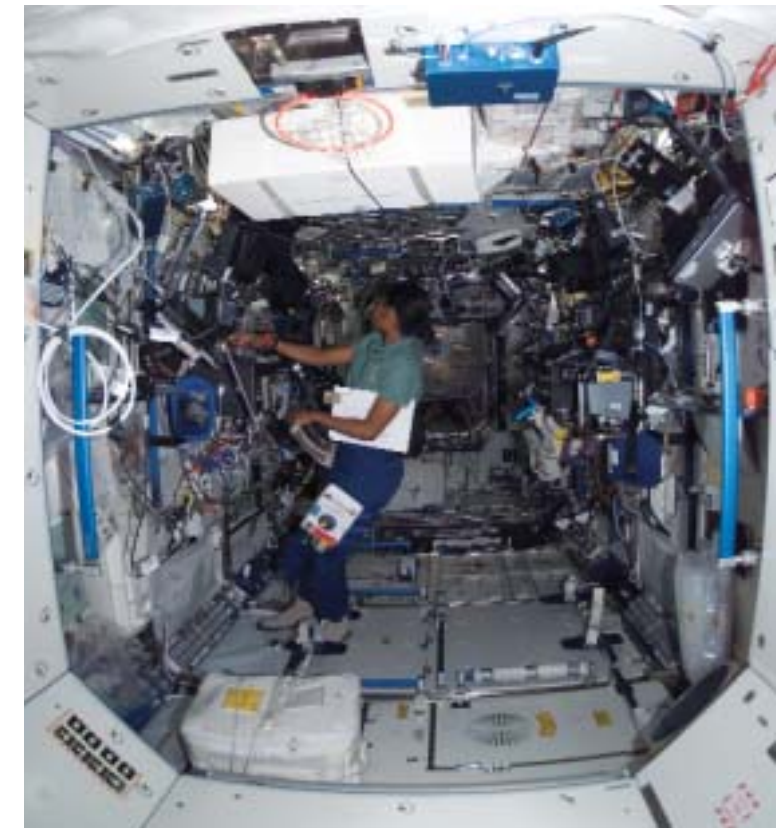
Astronaut Stephanie Wilson, STS-120 mission specialist, works the controls of the Space Station Remote Manipulator System (SSRMS), or Canadarm-2, in the Destiny laboratory of the ISS during flight-day-12 activities while the space shuttle Discovery is docked with the station.

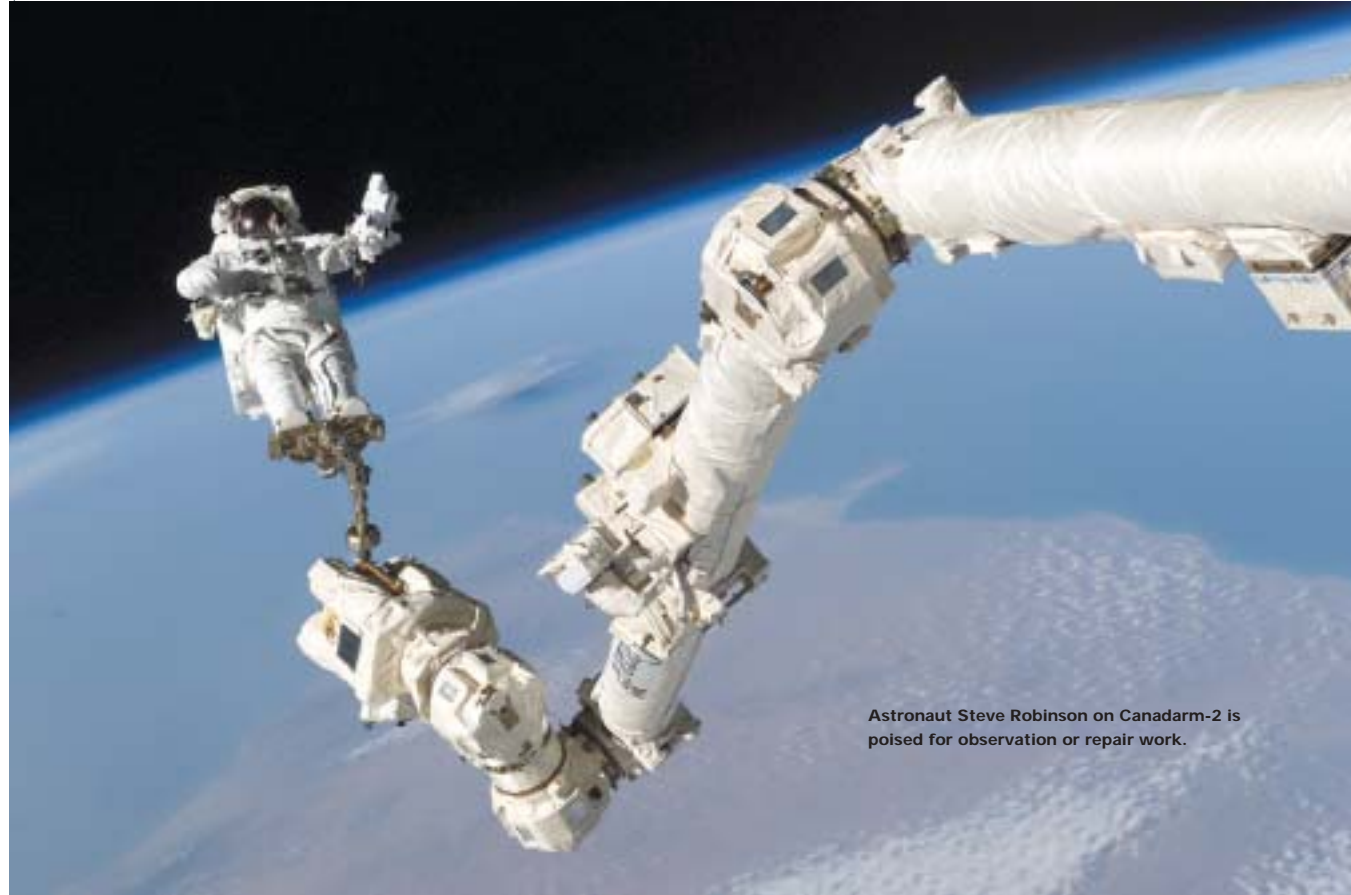
Astronaut Steve Robison on Canadarm-2 is poised for observation or repair work.

An astronaut perches on the end of a boom held by the ISS robot arm. This configuration was used on the repair EUA.

out—and, last summer, tested—a way to attach the work platform to the end of the sensor boom and then grab the other end of the boom with the robot arm and move the astronaut (at the end of the boom) to the more remote corners of the shuttle’s belly. The spacewalk test had shown that the boom-arm combination was still rigid enough for the astronaut on the far end not to be swayed back and forth too much and hit the heat shield under repair.
